Docket No. 217 – Development and Management Plan Inspection

Northeast Utilities Service Company Certificate of Environmental Compatibility and Public Need for the construction of a 345-kV electric transmission line and reconstruction of an existing 115-kV electric transmission line between Connecticut Light and Power Company's Plumtree Substation in Bethel, through the towns of Redding, Weston, and Wilton, and to the Norwalk Substation in Norwalk, Connecticut.

Date: June 28, 2006

Location: Overhead Line (Composite 345kV and 115kV Gallows Hill to Archers Lane,
345kV H-Frame Hoyts Hill to Gallows Hill, and Norwalk Section)

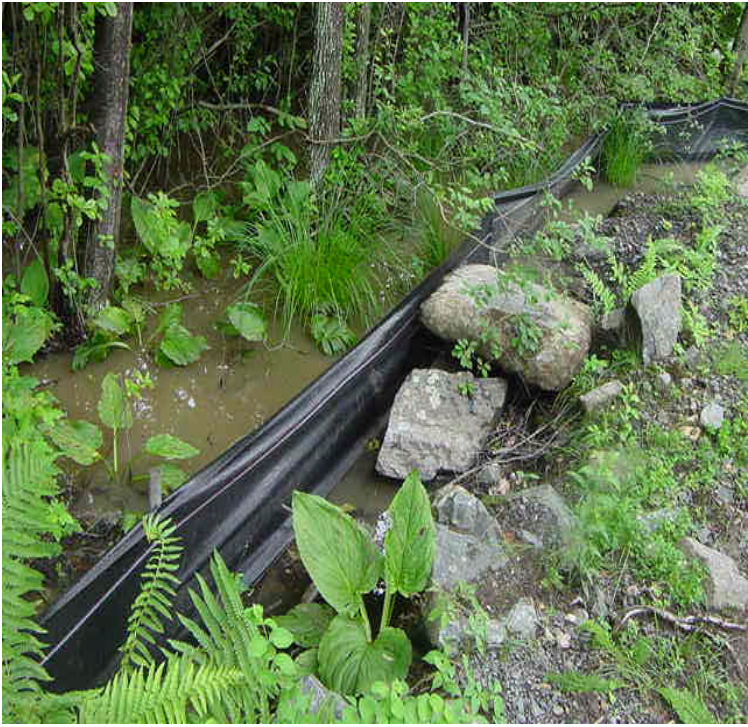
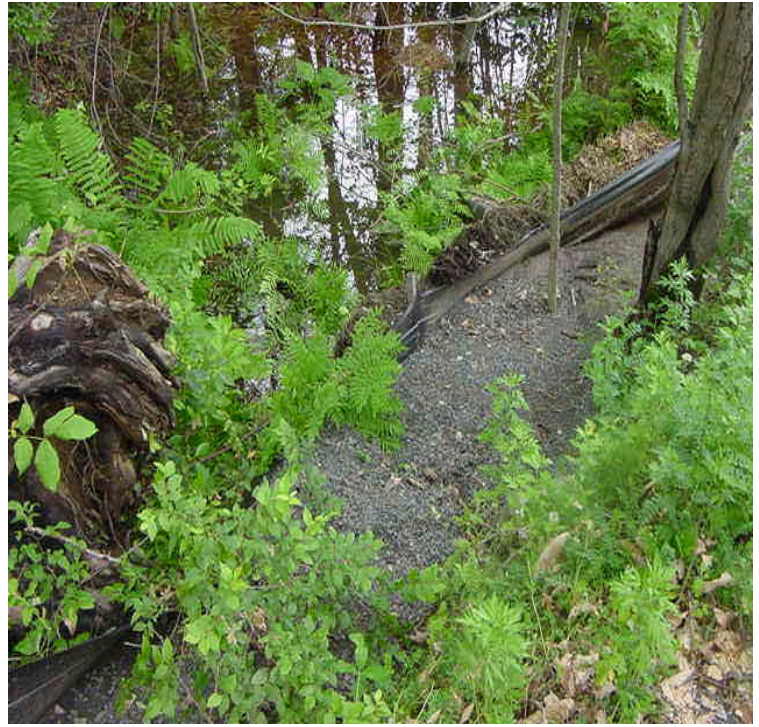
(Composite Section): Photo on the left shows where the 3rd wetland crossing past Archers Lane contained turbid water, likely run-off from the access road. Photo on the right shows the spot along the Archers Lane ROW where the access road stone was close to overtopping the fence near the 2nd wetland. It should be pulled back. 6/28/06

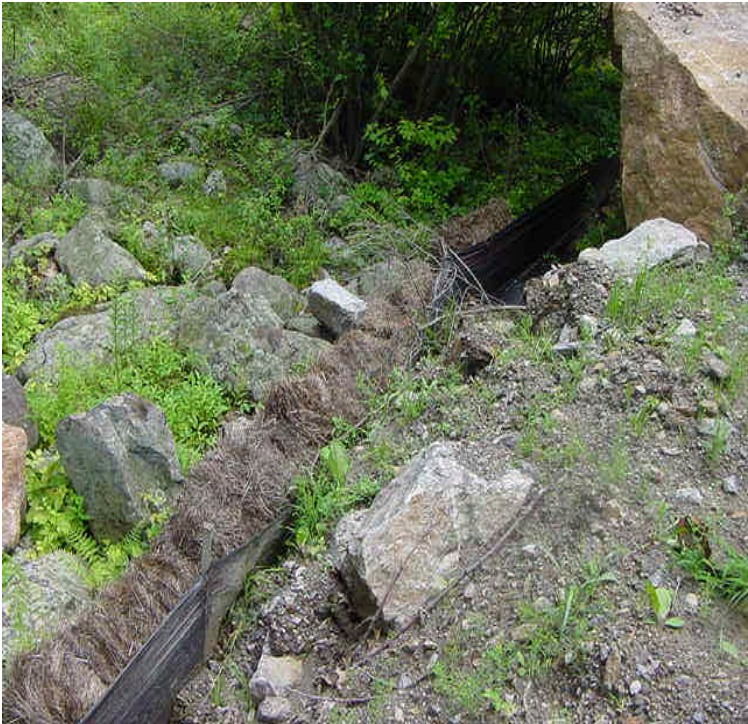
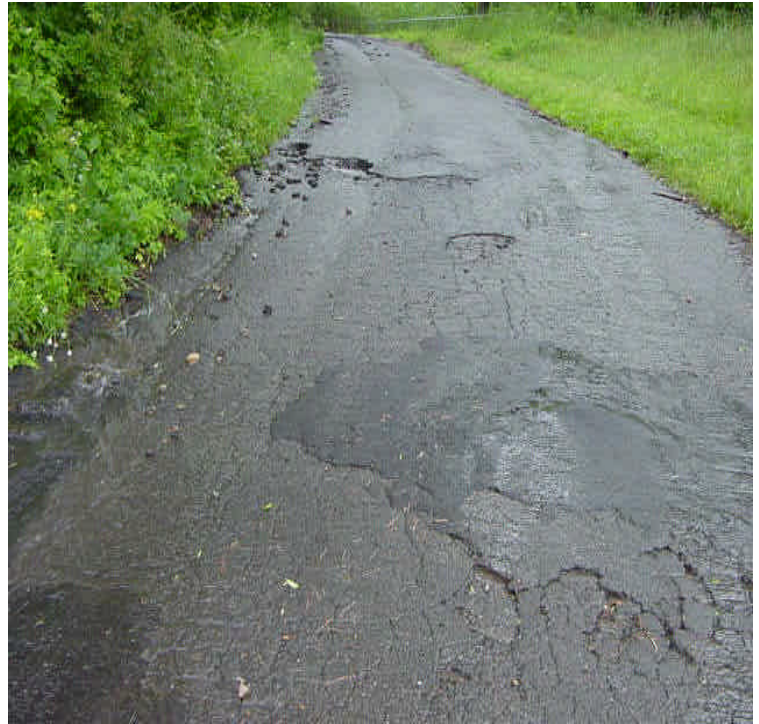
Photo on the left shows where controls were straightened up near structure #34 off Gallows Hill. Sediment is still encroaching on the area. (345kV H-Frame): Photo on the right shows water flowing down Webb Rd from Nashville Rd Ext. during the rain event. 6/28/06.

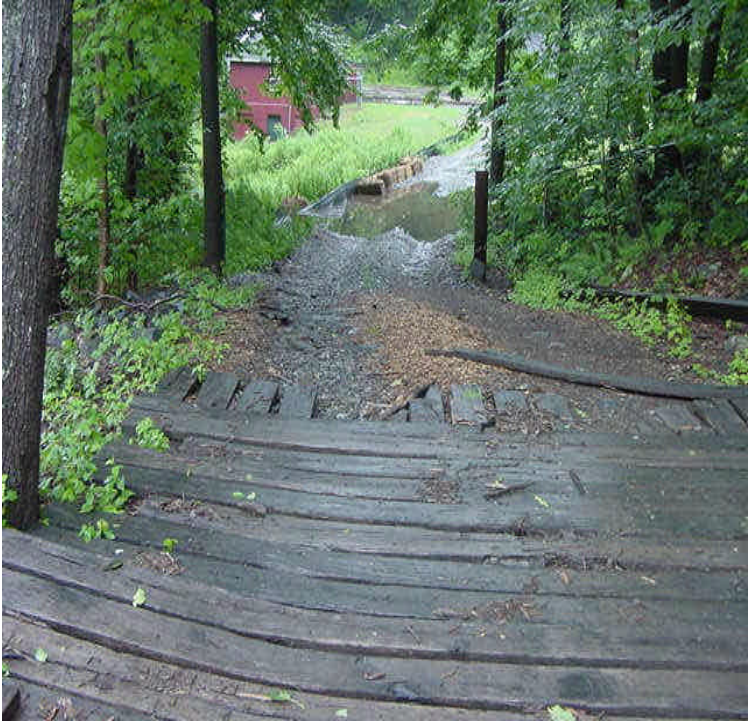
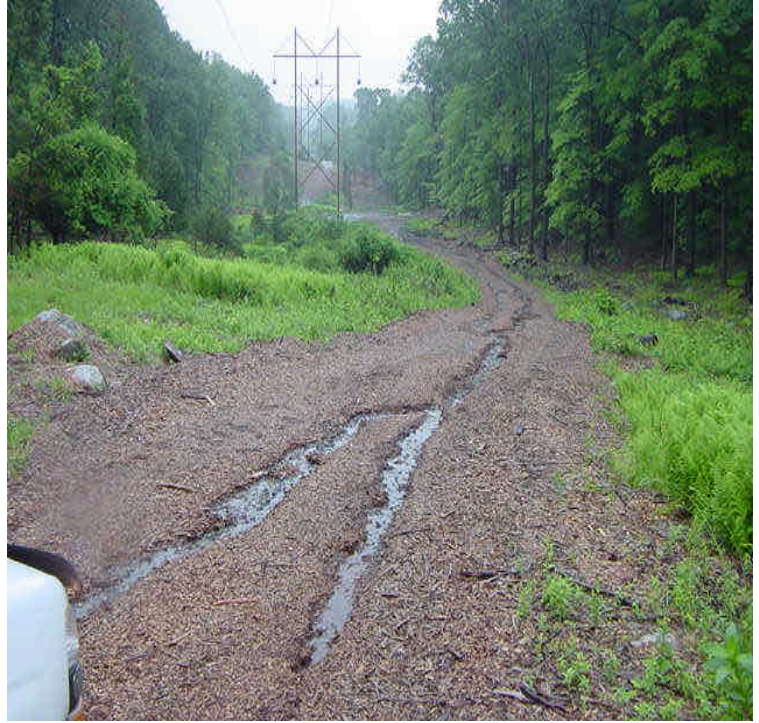
- Additional washouts were noted near the controls at Bethel water building from flow off Webb Rd. Additional controls were added during the inspection. 6/28/06.	- Continue to monitor for stability. Flow from Webb Rd during rain events is not project related and will be difficult to control 6/28/06	- Additional controls were installed

Photo on the left shows the entrance into the ROW. Water from Webb Rd had washed out some controls but more were being added at the time. Photo on the right shows washouts in the access road. This remains contained to the road but will be repaired when feasible. 6/28/06.

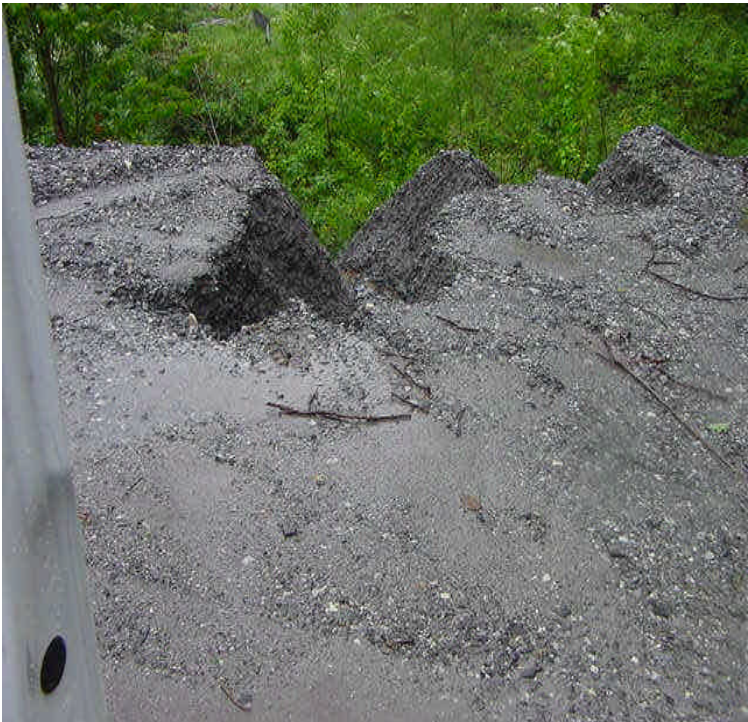
- A fairly large erosive washout was present in the road near structure #31. 6/28/06.	- Haybale check dams may help reduce run-off velocity and promote sheet flow. 6/28/06	- Needs attention when feasible

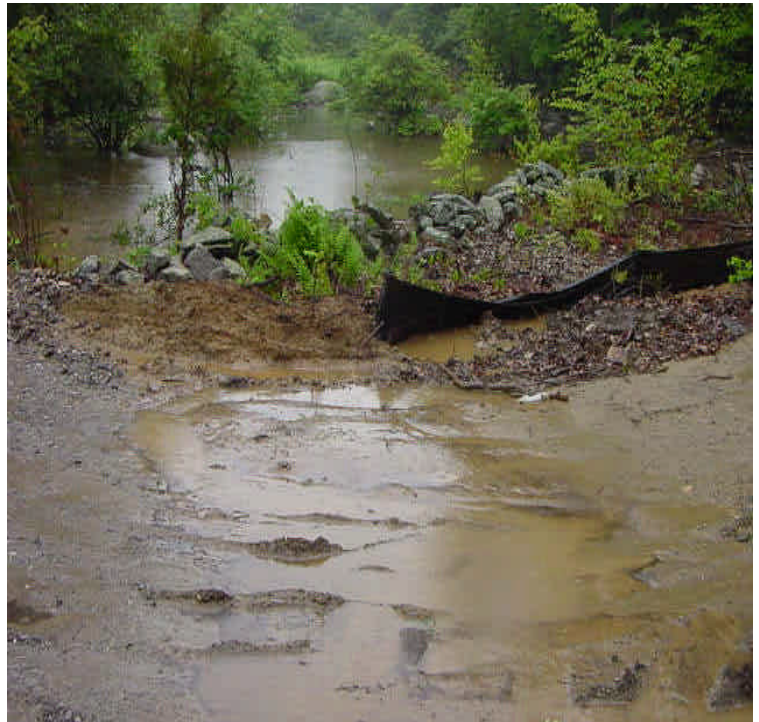
Photo on the left shows erosion in the access road stone near structure #31. Haybale check dams may reduce run-off velocity or promote sheet flow. Photo on the right shows where the residential driveway contractor near John Todd Way had eventually placed silt fence. Wetlands already contained turbid standing water. 6/28/06.

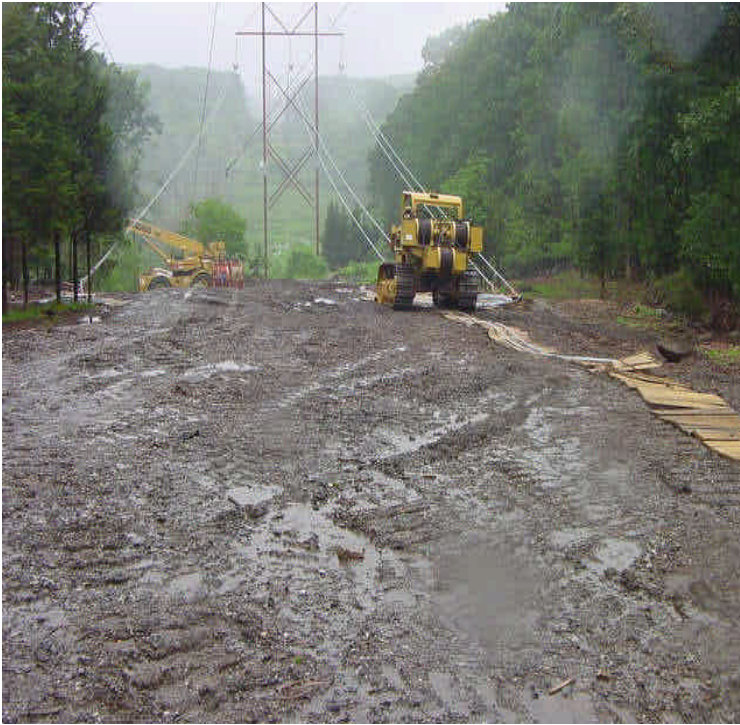
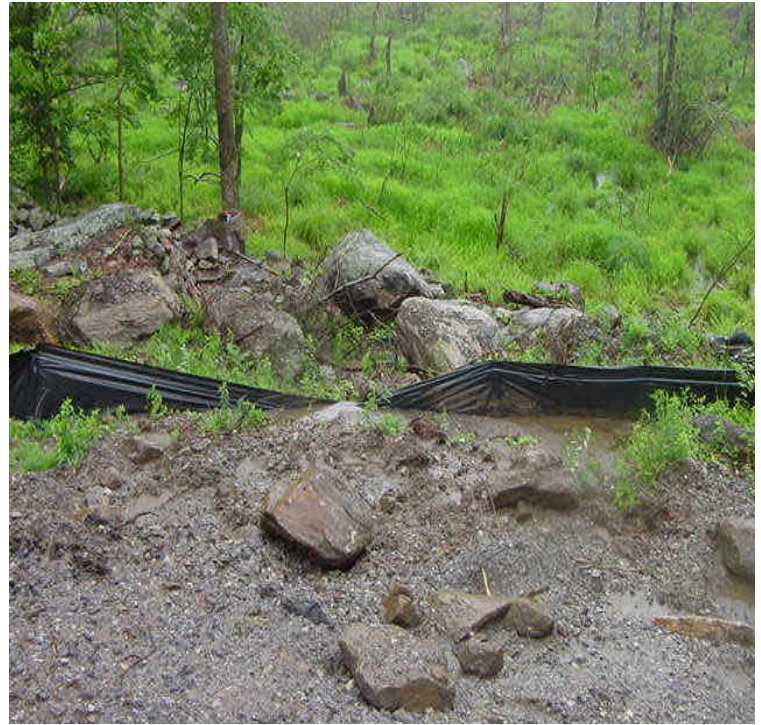
- Some additional clearing was needed for wire pulling near structure #24. Turbid run-off was noted. 6/28/06	-Provide additional erosion controls here. 6/28/06	-Needs attention -N/A
Norwalk Section	- Clearing of new ROW continues north of Kent Rd., coming in from the other end of the pond. 6/28/06.	- Be extremely careful to retain shrubs and vegetation where feasible. 5/25-6/20/06.	- Several areas near wetlands did have vines and shrubs in place.

Photo on the left shows the machinery in this same area pulling wire near structure #24. This work also required some additional clearing, resulting in turbid run-off to the wetland. Additional erosion controls are needed here. Photo on the right shows where silt fence repair is needed near this same structure. 6/28/06.

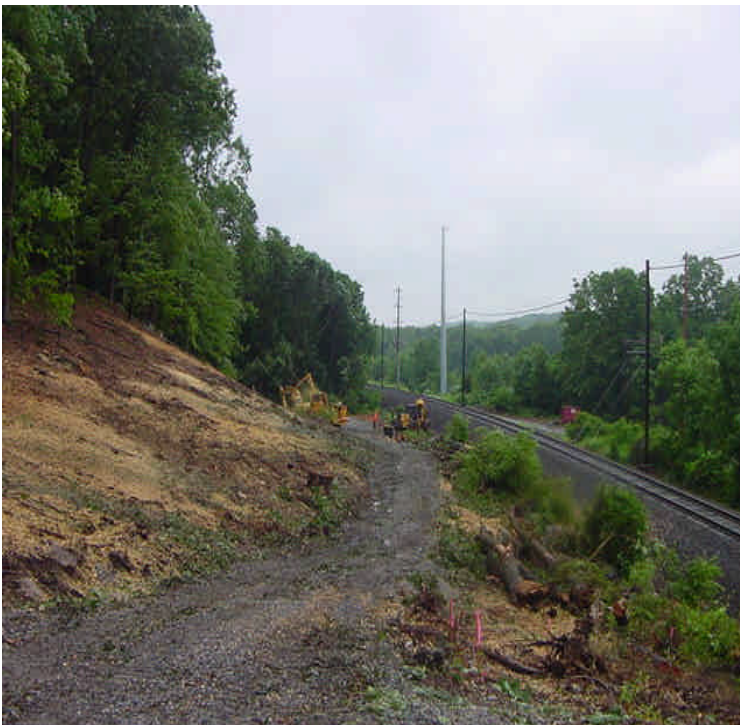
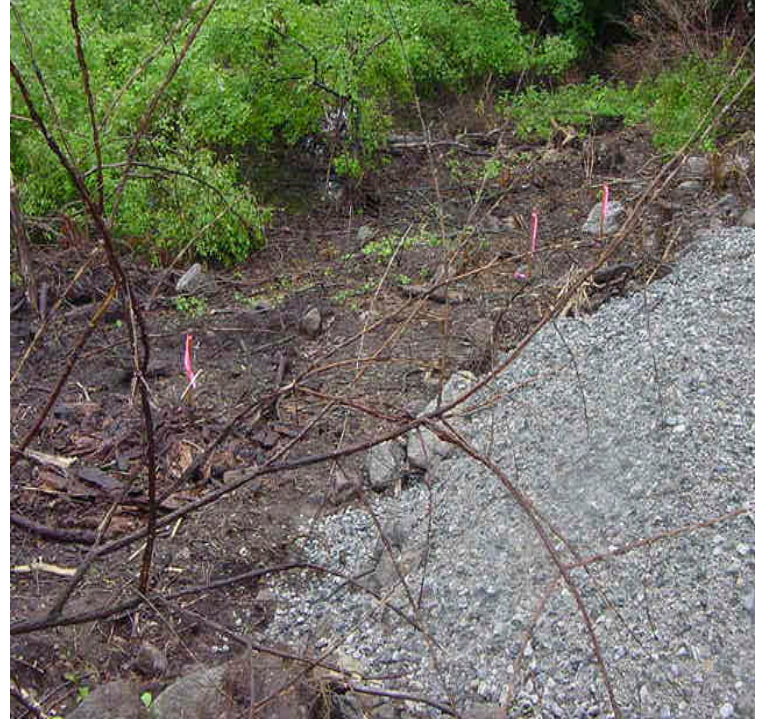
- Some access impact will occur at the edge of a wetland near the pond in order to access a foundation location. 6/28/06	- Mats and controls will be utilized in this area. 6/28/06	-N/A at this time

(Norwalk Section): Photo on the left shows a view of the newly cleared ROW off Wilton Terrace. Photo on the right shows a view of a structure location immediately adjacent to a wetland area. Mats and erosion controls will have to be installed here during drilling. 6/28/06

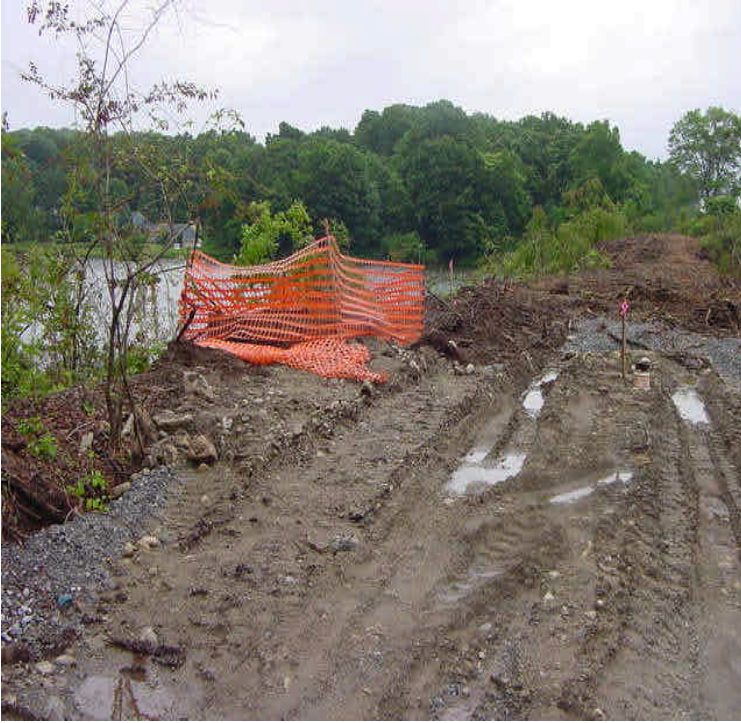
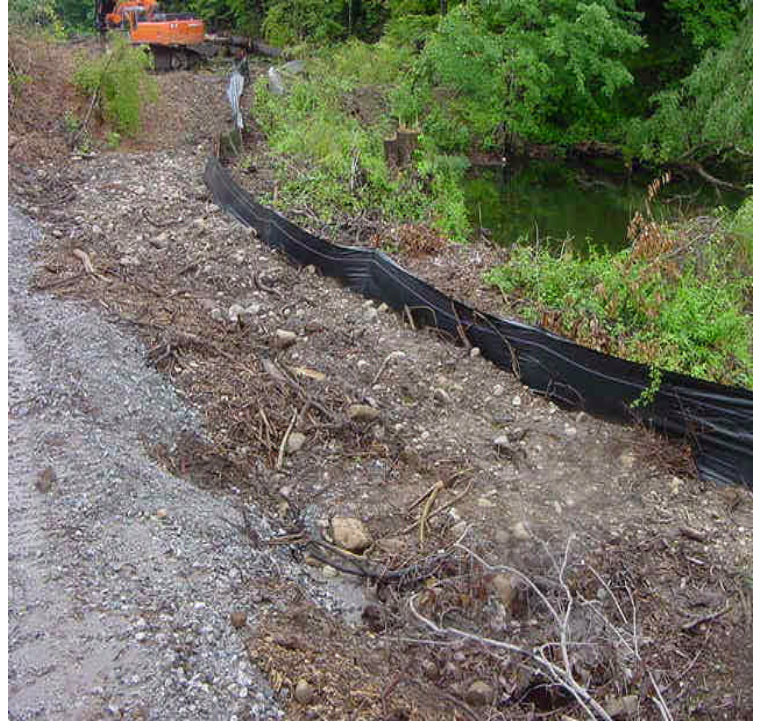
(Kent Rd north): Photo on the left shows a foundation hole drilled in the ROW section near the pond. Erosion controls were not placed between the work and the pond and should be installed. Photo on the right (background) shows some machinery parked fairly close to the pond. Vehicles should be parked away from resource areas whenever possible. 6/28/06

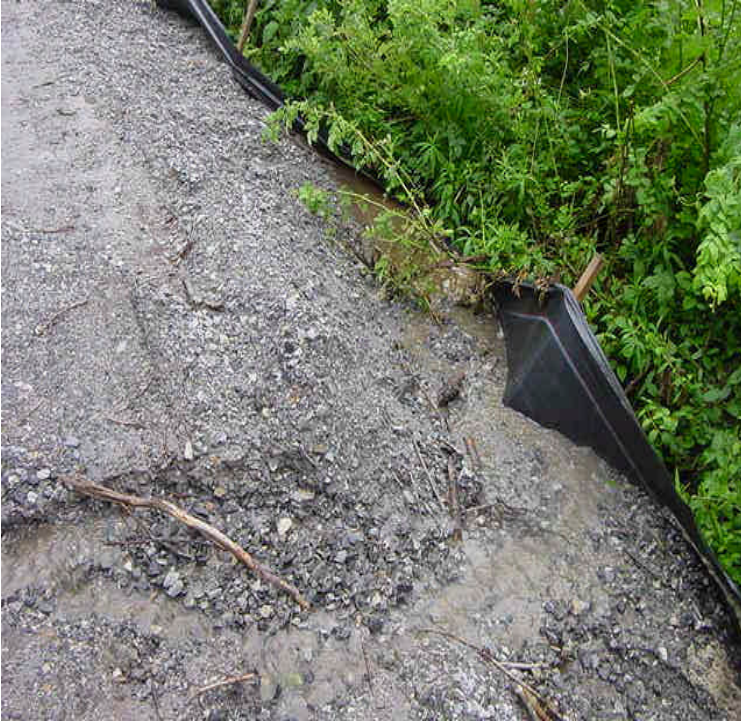
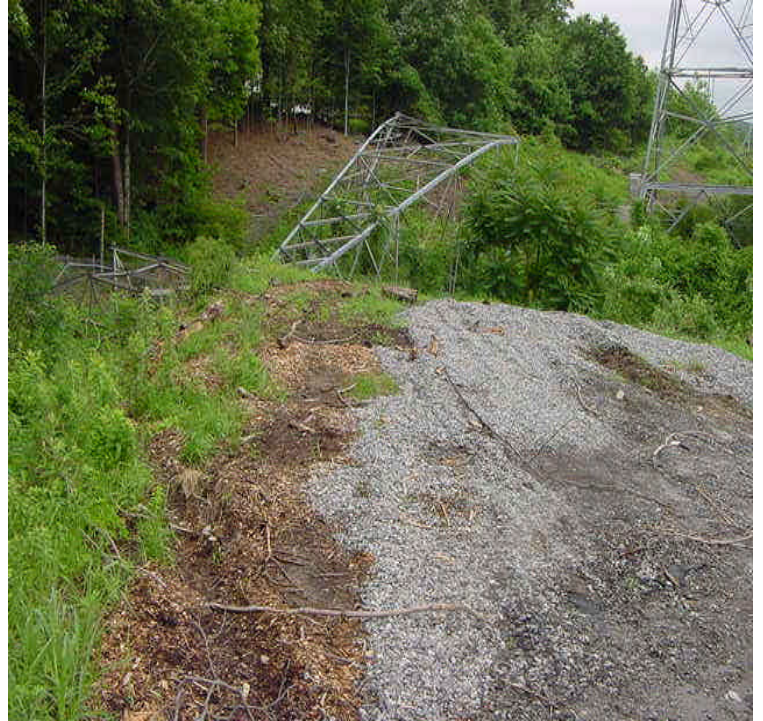
Photo on the left shows where run-off and stone were overtopping the silt fence along the access road south of Kent Rd. This should be pulled back and repaired. Photo on the right shows more towers down and waiting for removal. 6/28/06
